Failure Analysis of CCD Image Sensors using SQUID and GMR Magnetic Current Imaging

Frederick S. Felt

Failure Analysis Laboratory

NASA Goddard Space Flight Center

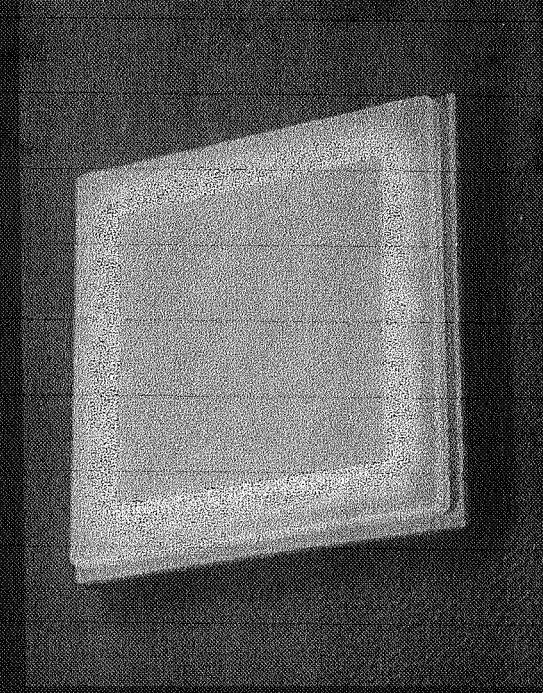
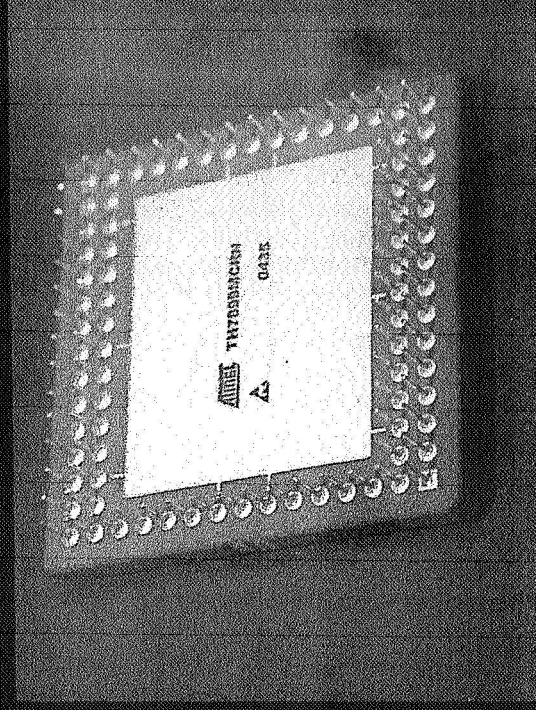
TH7899M CCD Device

- Instrument grade CCD, 14 μm square pixels
- Fiber optic faceplate covers array
- M2 aluminum light shield over periphery
- Manufacturer: device ESD sensitive to 20V

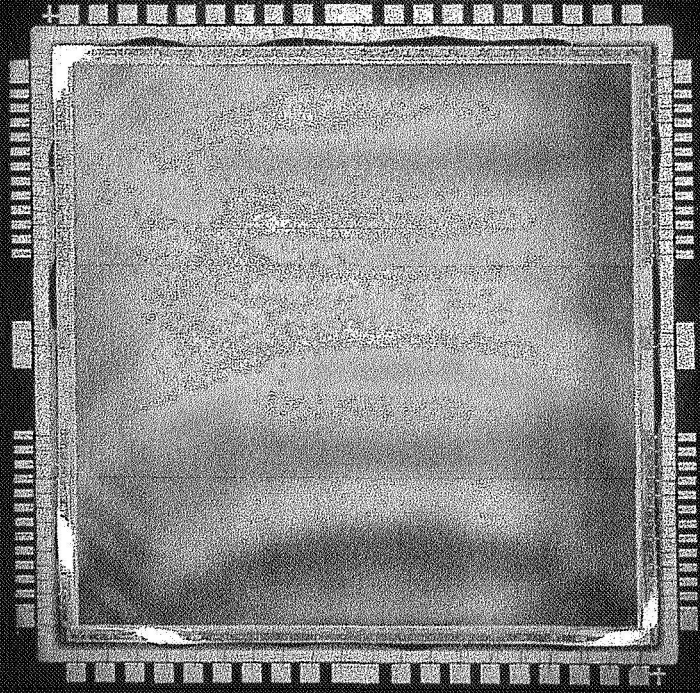
Initial Deprocessing

- Faceplate removed with solvent
- Glue removed by razor/O₂ plasma
- Aluminum light shield over periphery

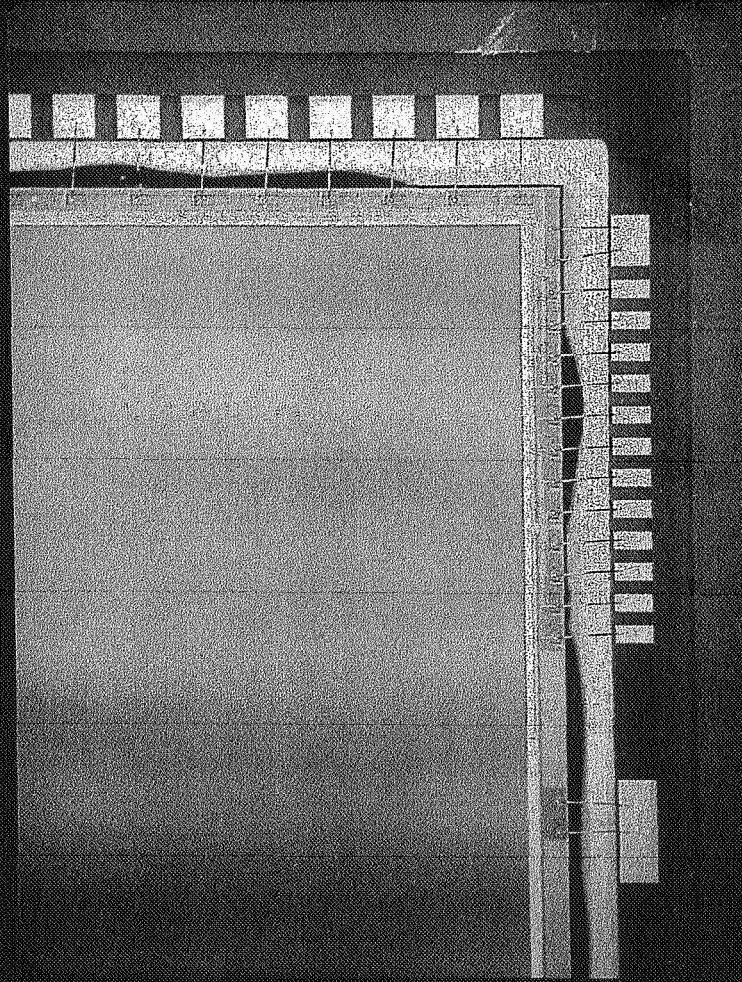
Initial Deprocessing

- Faceplate removed with solvent
- Glue removed by razor/O₂ plasma
- Aluminum light shield noted

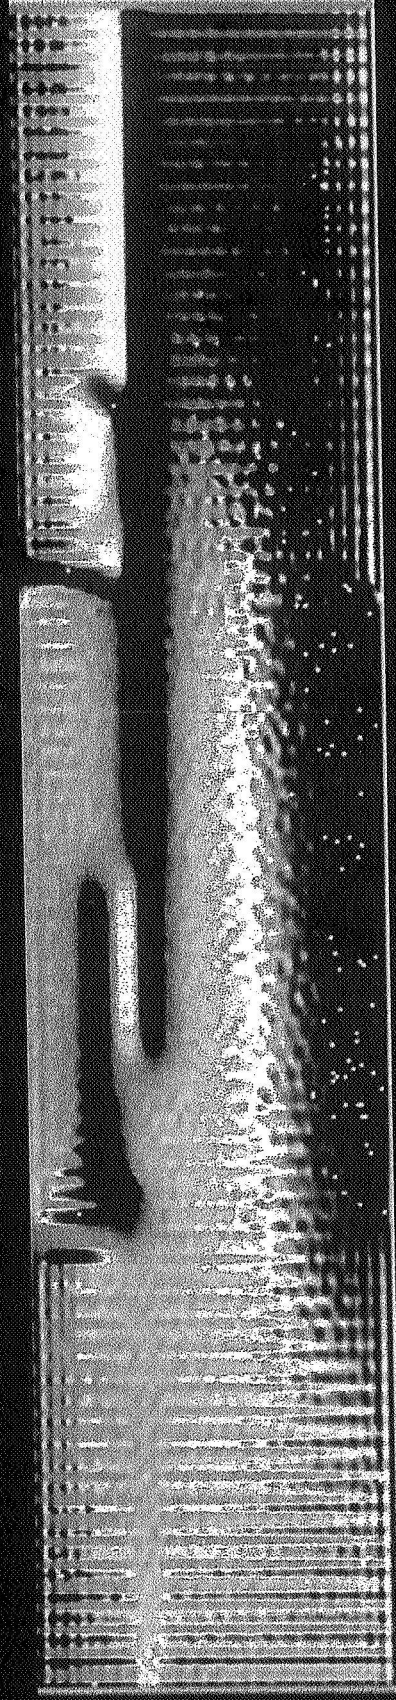
SQUID Current Map

- Overlay: current map and optical image
- Scan plane at 50 microns
- Ceramic package blocks scan at CCD corner

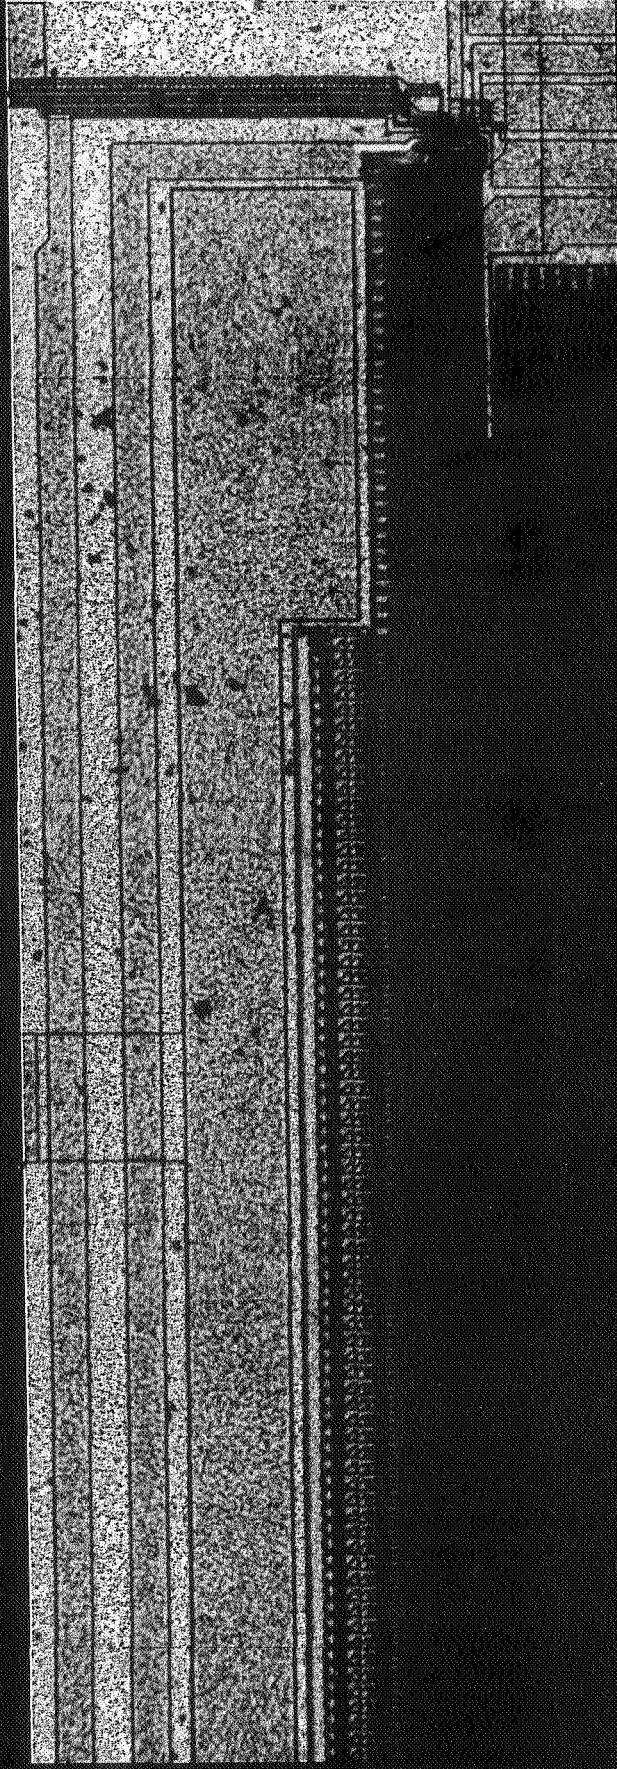
GMR Set-up and Current Map

- Probe contacts CCD surface
- 99 kHz frequency
- 2.0 mA current flow

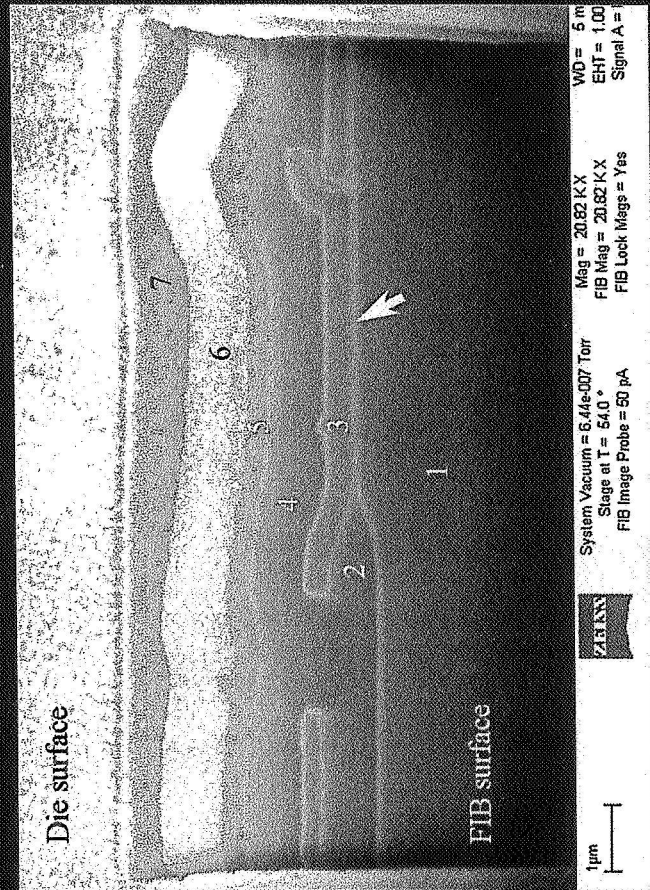
SWA/LA1 short L1

- SN06 FIB cross section
- Evidence of cracking, bridging

- ESD or line transient
- ..with possible secondary damage caused by IR testing

ESD protection technology and practices used at the test laboratory where these devices are being tested in the application mode is being reviewed to prevent ESD damage to a second set of CCD devices.
